Manhole Inspection Summary

Manhole # S67U__001MH

Location Address: **6200 Seaforth St.**

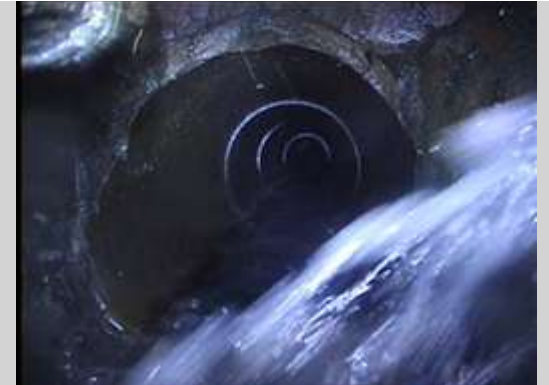
12 O'Clock Outflow

12 in. Circular Gravity Sewer
Pipe Out @ 12 O'Clock

Pipe Height: **13.2** (in.) Rod and Bar (Angled)
Pipe Material: **Clay** ☐ Pipe Lined
Invert Depth: **17.00** (ft.) Flow Characteristics: **Fast**
Deposits: ☒ None ☐ Mud ☐ Sludge ☐ Debris ☐ Grease
Silt Depth: (in.) Deposits Extent:
Infiltration: **None** Pipe Seal Cond: **Sound**

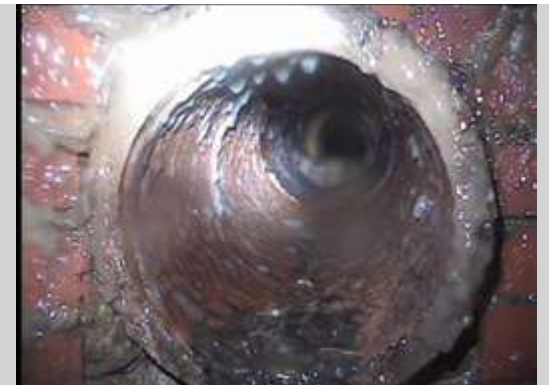
3 O'Clock Inflow

8 in. Circular Gravity Sewer
Pipe In @ 3 O'Clock

Pipe Height: **7.2** (in.) Rod and Bar (Angled)
Pipe Material: **Clay** ☐ Pipe Lined
Invert Depth: **7.58** (ft.) Flow Characteristics: **Fast**
Deposits: ☒ None ☐ Mud ☐ Sludge ☐ Debris ☐ Grease
Silt Depth: (in.) Deposits Extent:
Infiltration: **None** Pipe Seal Cond: **Sound**

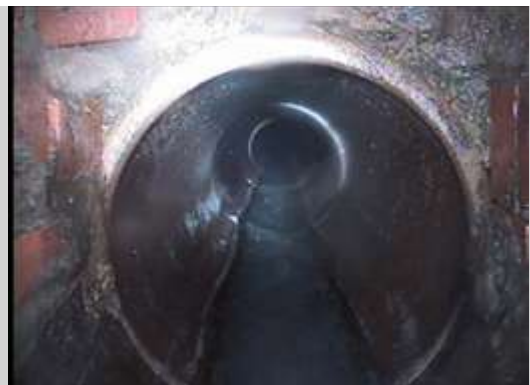
6 O'Clock Inflow

12 in. Circular Gravity Sewer
Pipe In @ 6 O'Clock

Pipe Height: **12** (in.) Rod and Bar (Angled)

Pipe Material: **Clay** ☐ Pipe Lined

Infiltration: **None** Pipe Seal Cond: **Sound**
